## HUB REVIEW FINDINGS - VALLEJO FERRY TERMINAL

October 25, 2006

MTC Regional Transit Hub Performance Review Project

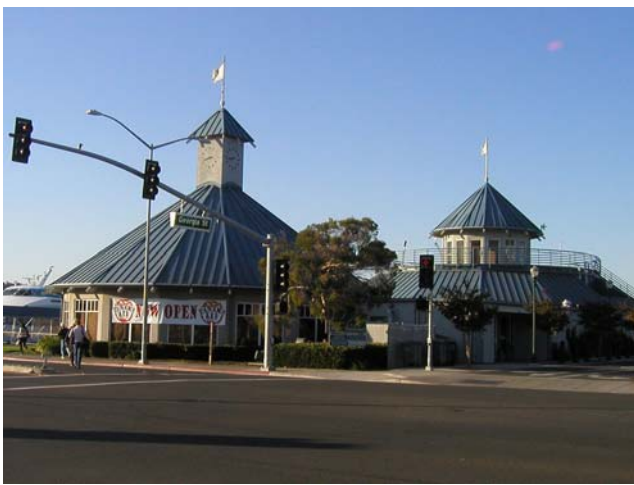
1. Main Ferry Terminal building. Note lack of identification signs, logos and entry signs.

- Provide a consistent hub identification sign that incorporates the branding of Baylink and the connecting bus services. Entry signs should identify all operators (including their logos) serving this hub (photos #1, 2, 3);
- Install signs in the parking lots that clearly identify this facility and the entry pathway to the terminal;
- An additional entrance sign is needed on the north side of the terminal/waiting room building (photo #1);

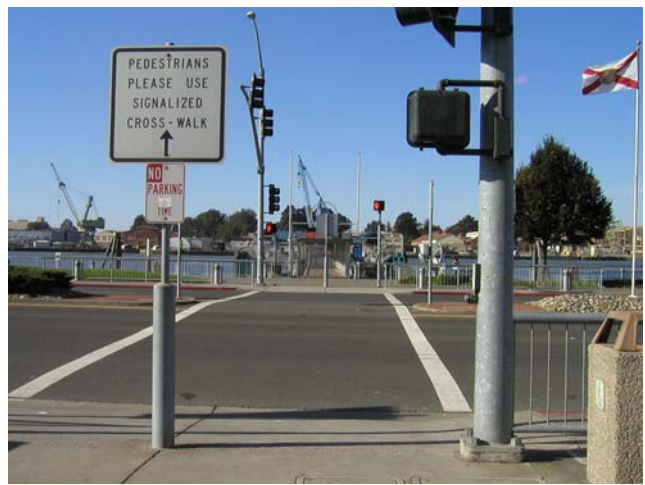
2. Main pedestrian crossing to Ferry Terminal. Note lack of Ferry Terminal name, logos, entrance and directional signs.

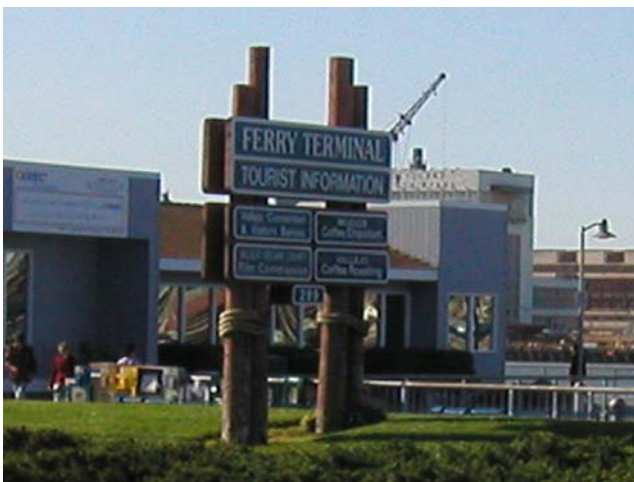
3. Hub identification sign. Lacks operator logos and branding.

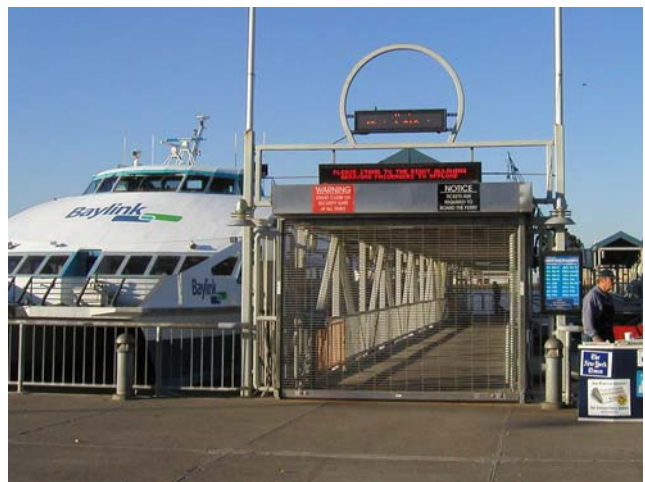
4. Entrance and exit to ferry pier. Lacks directional information to terminal and other transit services. Note real-time signs above dock entry.
--

- Install signs at all decision points in the hub, which direct passengers between the ferry, the buses, the terminal, ticket machines, RTIC's, bicycle facilities, and delineates the accessible pathway throughout the hub facility including:
  - The ferry piers (photo #4);
  - Bus stops on both sides of Mare Island Way (photos #5, 6) ;
  - The ferry terminal, waiting room and commercial services (photos #7, 8).
- Use a consistent set of graphics, fonts, and colors for directional signs (see checklist questions #7, 8, 12, 14, 16);
- Add international icons and symbols where appropriate;
- MTC will work with a transit operator who will take the lead on the development of a comprehensive and consistent wayfinding sign program, including providing funding for program development and P S & E.

- Establish one or two locations in the hub where RTIC(s) could be provided. The RTIC(s) would include:
  1. The regional 511.org transit map; and
  2. Subregional or system map for local operators.
- Recommended RTIC locations:
  - Inside terminal/waiting room: Replace existing customer information displays with RTIC and local operator information (photos #8, 13, 14);
  - Additional optional location: At the main entrance to the ferry piers where the majority of passengers enter or exit (photo #4).

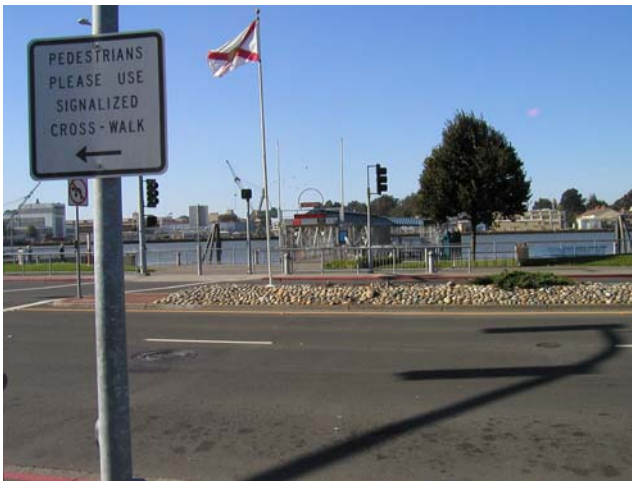
5. Main pedestrian entrance on Mare Island Way. Without the ferry at the pier, it is difficult to identify the Ferry Terminal.

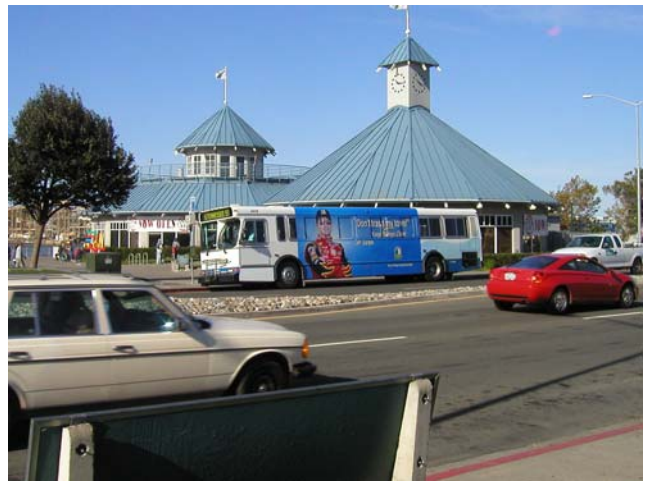
6. Bus stops on Mare Island Way. They do not identify the Ferry Terminal at the stop.

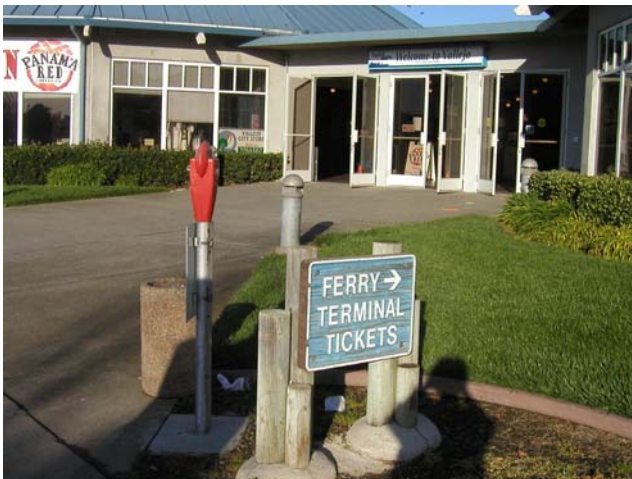
7. Main entrance to Ferry Terminal building. Lacks identification, logos, directions and connecting transit signs.

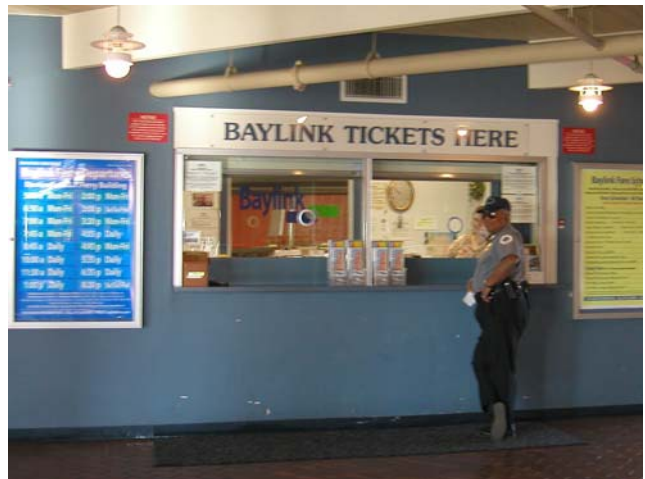
8. Ticket window inside Terminal provides an excellent service and is a key decision point. Additional customer information could be posted or available at this location such as regional transit information (RTIC), local transit maps, schedules and fares, real-time arrival and departure times, local bicycle facilities maps, and directions to connecting transit or bike facilities.

- Improving the existing real-time information at the ferry pier to be larger and more visible (photo #15);
- Installing new real-time signs inside the terminal building near the ticket window or waiting room area. These signs should provide information about the Baylink ferry and bus information for Vallejo, Benicia, and Napa Transit services (photos #8, 14).

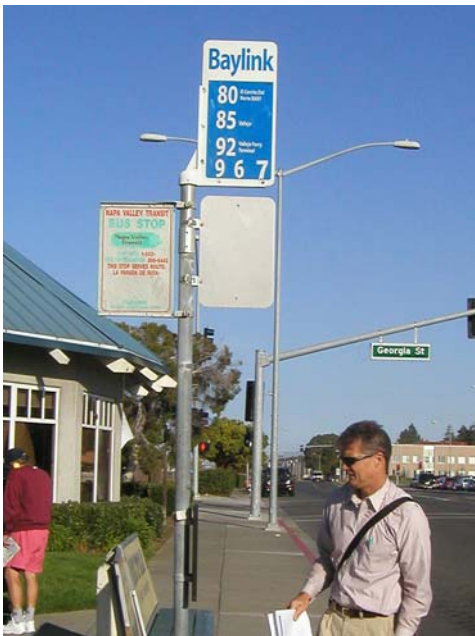
9. Bus stops on west side of Mare Island Way. The information that is provided is inconsistent and incomplete.

- Confirm that all bus stop signs have agency logos that are large and bold, can be seen from each approach direction and that route identification complies with 2004 ADAAG Guidelines (see checklist questions #21, 23, 24; photos #9 - 12);
- Install consistent Braille signs on all bus stop poles and/or shelters. Use mounting hardware that allows for changeable route information (see checklist question #23);

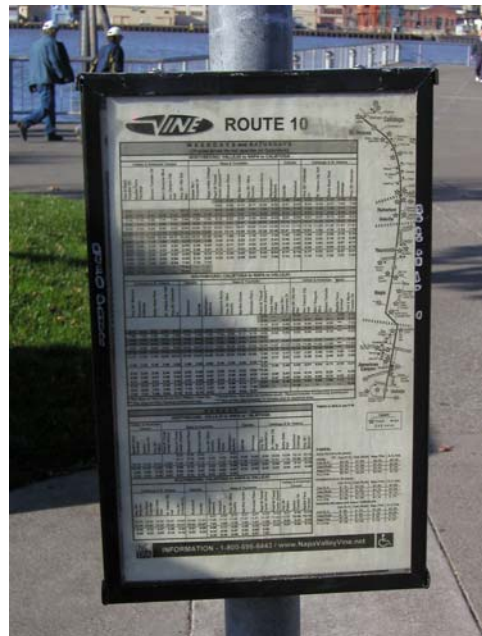
10. Napa Vine Route 10 schedule and route. Lacks Braille and other 2004 ADAAG requirements.

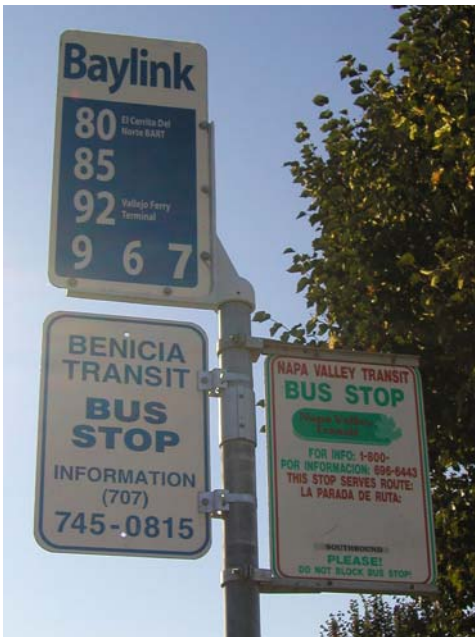
11. Bus stop signs. Some do not comply with 2004 ADAAG guidelines.

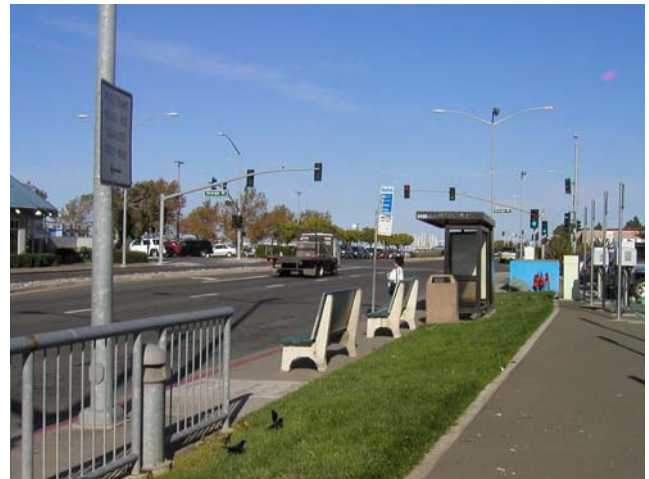
12. Bus stops on east side of Mare Island Way. Transit route maps, schedule and connecting transit information is inconsistent and incomplete.

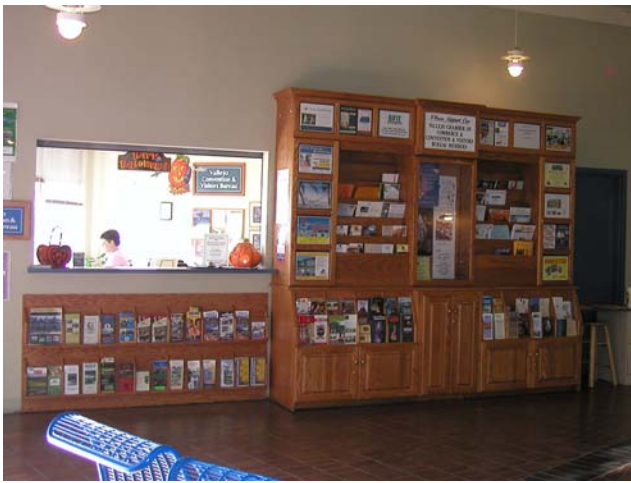
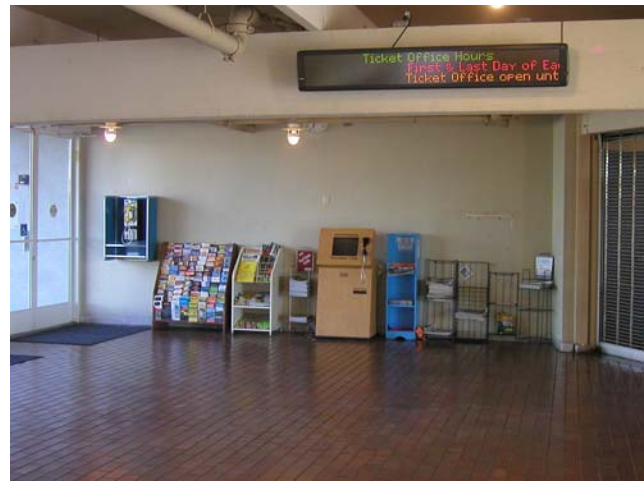
Waiting room and customer service area inside the Terminal Building is an excellent customer service and much appreciated on a cold, windy day. This is an ideal location for regional transit information (RTIC), local transit maps, schedules and fare information, real-time arrival/departure information, local bicycle facilities maps, and directions or maps to connecting transit or bike facilities.

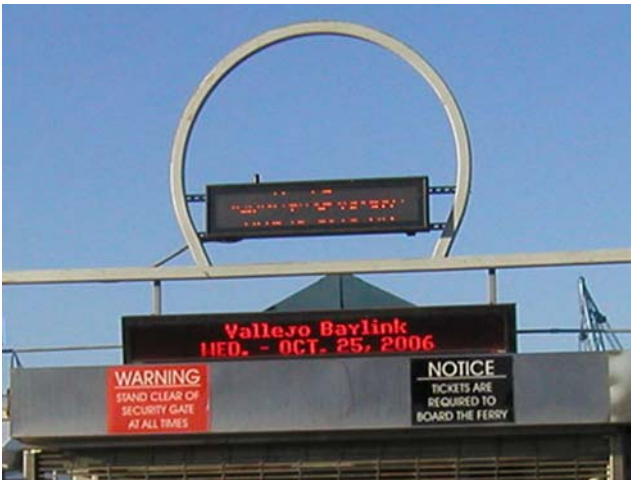
15. Main ferry pier entry/exit. Excellent location for directional informational and new larger and more visible real-time signs.
